**Flood Control Project Maintenance  
Levee Inspections**

**Fall 2011 Levee Maintenance Deficiency Summary Report**

**Reclamation District No. 1500 Sutter Basin**

**Levee Inspection Report By Mile - Fall 2011**

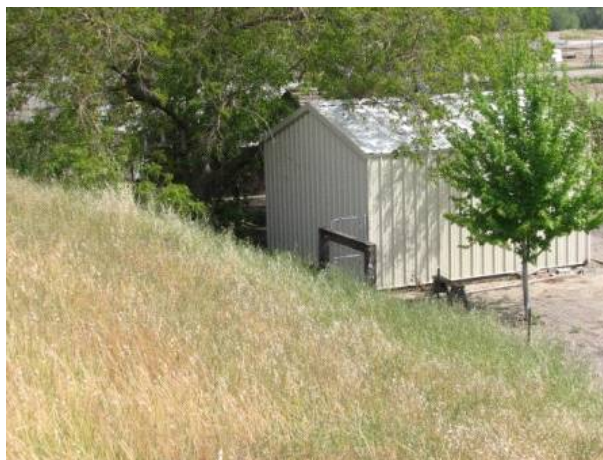
johngw\_f\_20110923\_424.jpg

The building is within the easement of the levee toe.

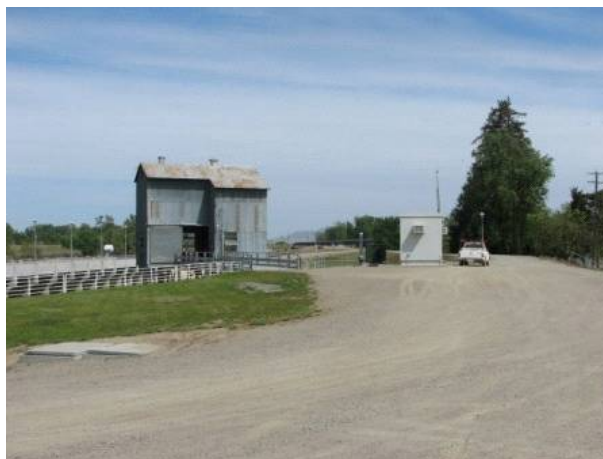
johngw\_f\_20110923\_426.jpg

Levee Mile Report Line	84
Start Levee Mile	33.41
End Levee Mile	33.41
Location	Water Side
Category	Earthen Levee
Item	Encroachments

The buildings are on the waterside of the crown. Control buildings for the pumping plant.

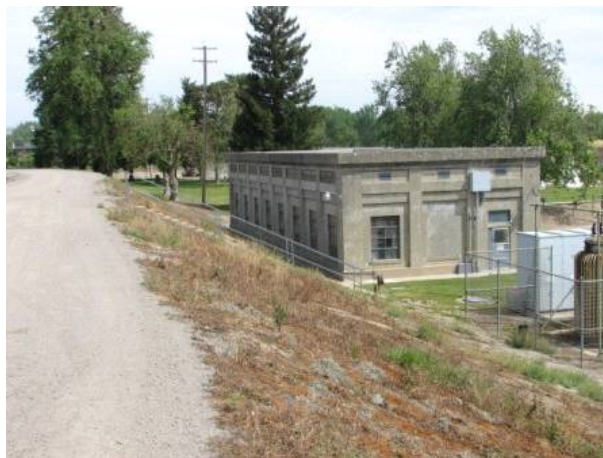
johngw\_f\_20110923\_425.jpg

Levee Mile Report Line	85
Start Levee Mile	33.41
End Levee Mile	33.41
Location	Land Side
Category	Earthen Levee
Item	Encroachments

The building is the pumping plant for Sutter Municipal.

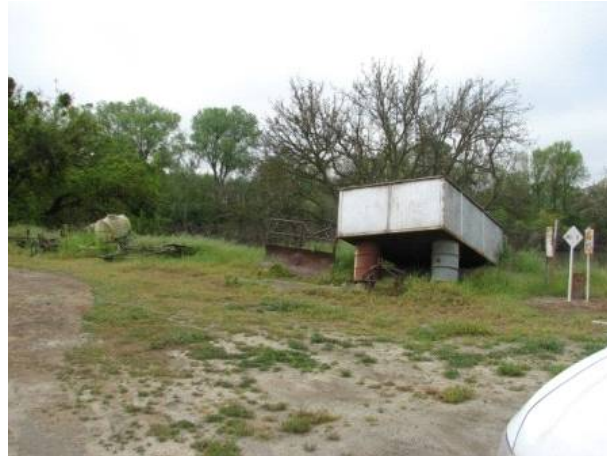
Levee Mile Report Line	1
Start Levee Mile	0.01
End Levee Mile	0.01
Location	Water Side
Category	Earthen Levee
Item	Encroachments
Farm equipment is stored on crown at L.M. 0.0	
johngw_f_20110923_582.jpg

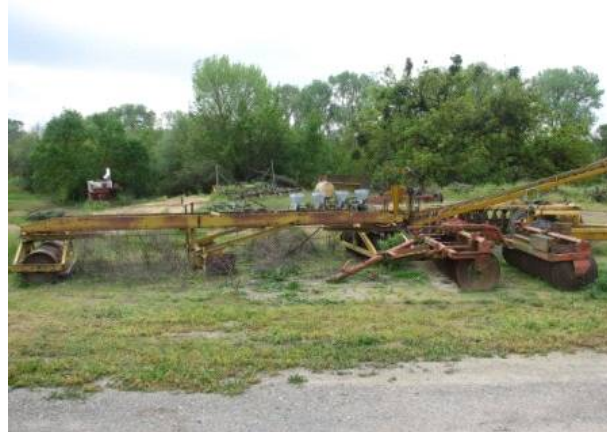
Levee Mile Report Line	1
Start Levee Mile	0.01
End Levee Mile	0.01
Location	Water Side
Category	Earthen Levee
Item	Encroachments
This is another photo of equipment on levee crown.	
johngw_f_20110923_583.jpg

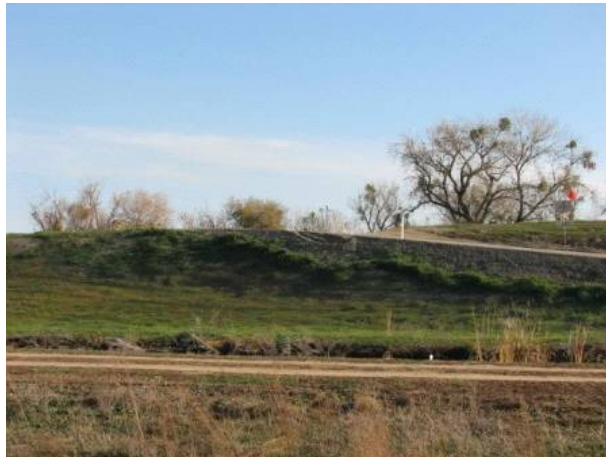
johngw\_f\_20110923\_584.jpg

Levee Mile Report Line	5
Start Levee Mile	11.03
End Levee Mile	11.03
Location	Crown
Category	Earthen Levee
Item	Crown Surface / Depressions / Rutting

cross view of levee crown

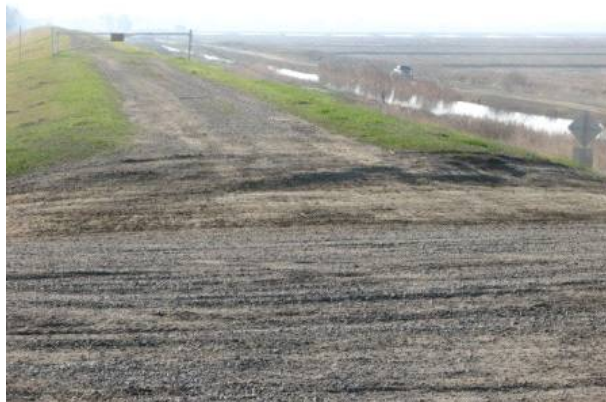
johngw\_f\_20110923\_585.jpg

Levee Mile Report Line	5
Start Levee Mile	11.03
End Levee Mile	11.03
Location	Crown
Category	Earthen Levee
Item	Crown Surface / Depressions / Rutting

dip coming off the crown of levee

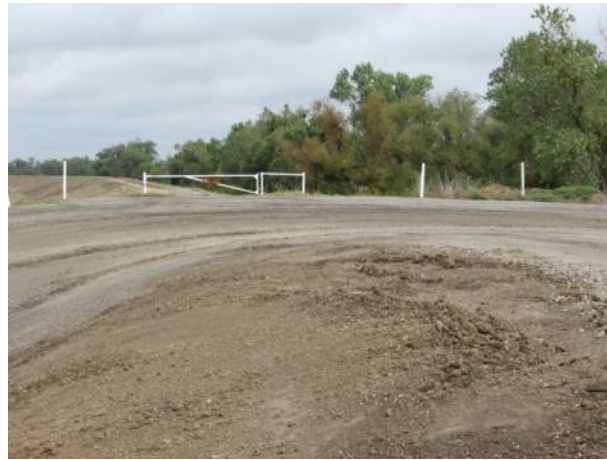
johngw\_f\_20111007\_839.jpg

The AB on the county rd has been pushed to the outside edge of the curve. The crown needs to be re-graded to raise the depression.

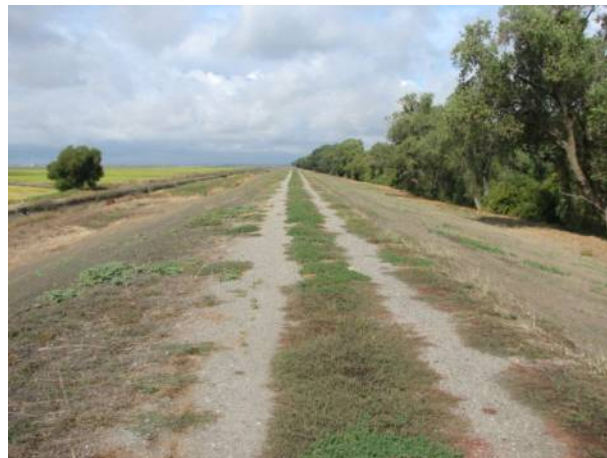
johngw\_f\_20111007\_841.jpg

Low growing vegetation is on the crown.

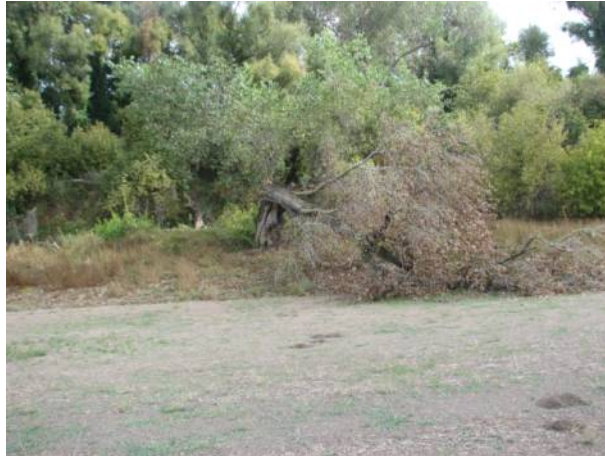
johngw\_f\_20111007\_842.jpg

10	19.63	19.63	Earthen Levee	Trim / Thin Trees	WS	C	Thin trees to allow visibility of the ground and room to flood fight. Inspector Comments: A cottonwood tree has fallen. Need to cut up the tree. Repair the damage caused by the root ball.	39.005358 ° -121.735754 °	39.005358 ° -121.735754 °	11
11	19.96	19.96	Earthen Levee	Trim / Thin Trees	WS	W	Thin trees to allow visibility of the ground and room to flood fight. Inspector Comments: Old cottonwood tree broke in half and fell on the toe need to cut up and remove.	39.010056 ° -121.737077 °	39.010056 ° -121.737077 °	14 Y

The cottonwood tree needs to be cut up and removed off the toe.
